Our Reference: 21454:NB1332

**RE: LEVEL 1 EARTHWORKS INSPECTION AND TESTING
OFFICER CENTRAL – DAM BACKFILL (OFFICER)**

Job No 21454
 Report No 21454/R001
 Date Issued 13/01/2022

Job No 21454
 Report No 21454/R002
 Date Issued 15/01/2022

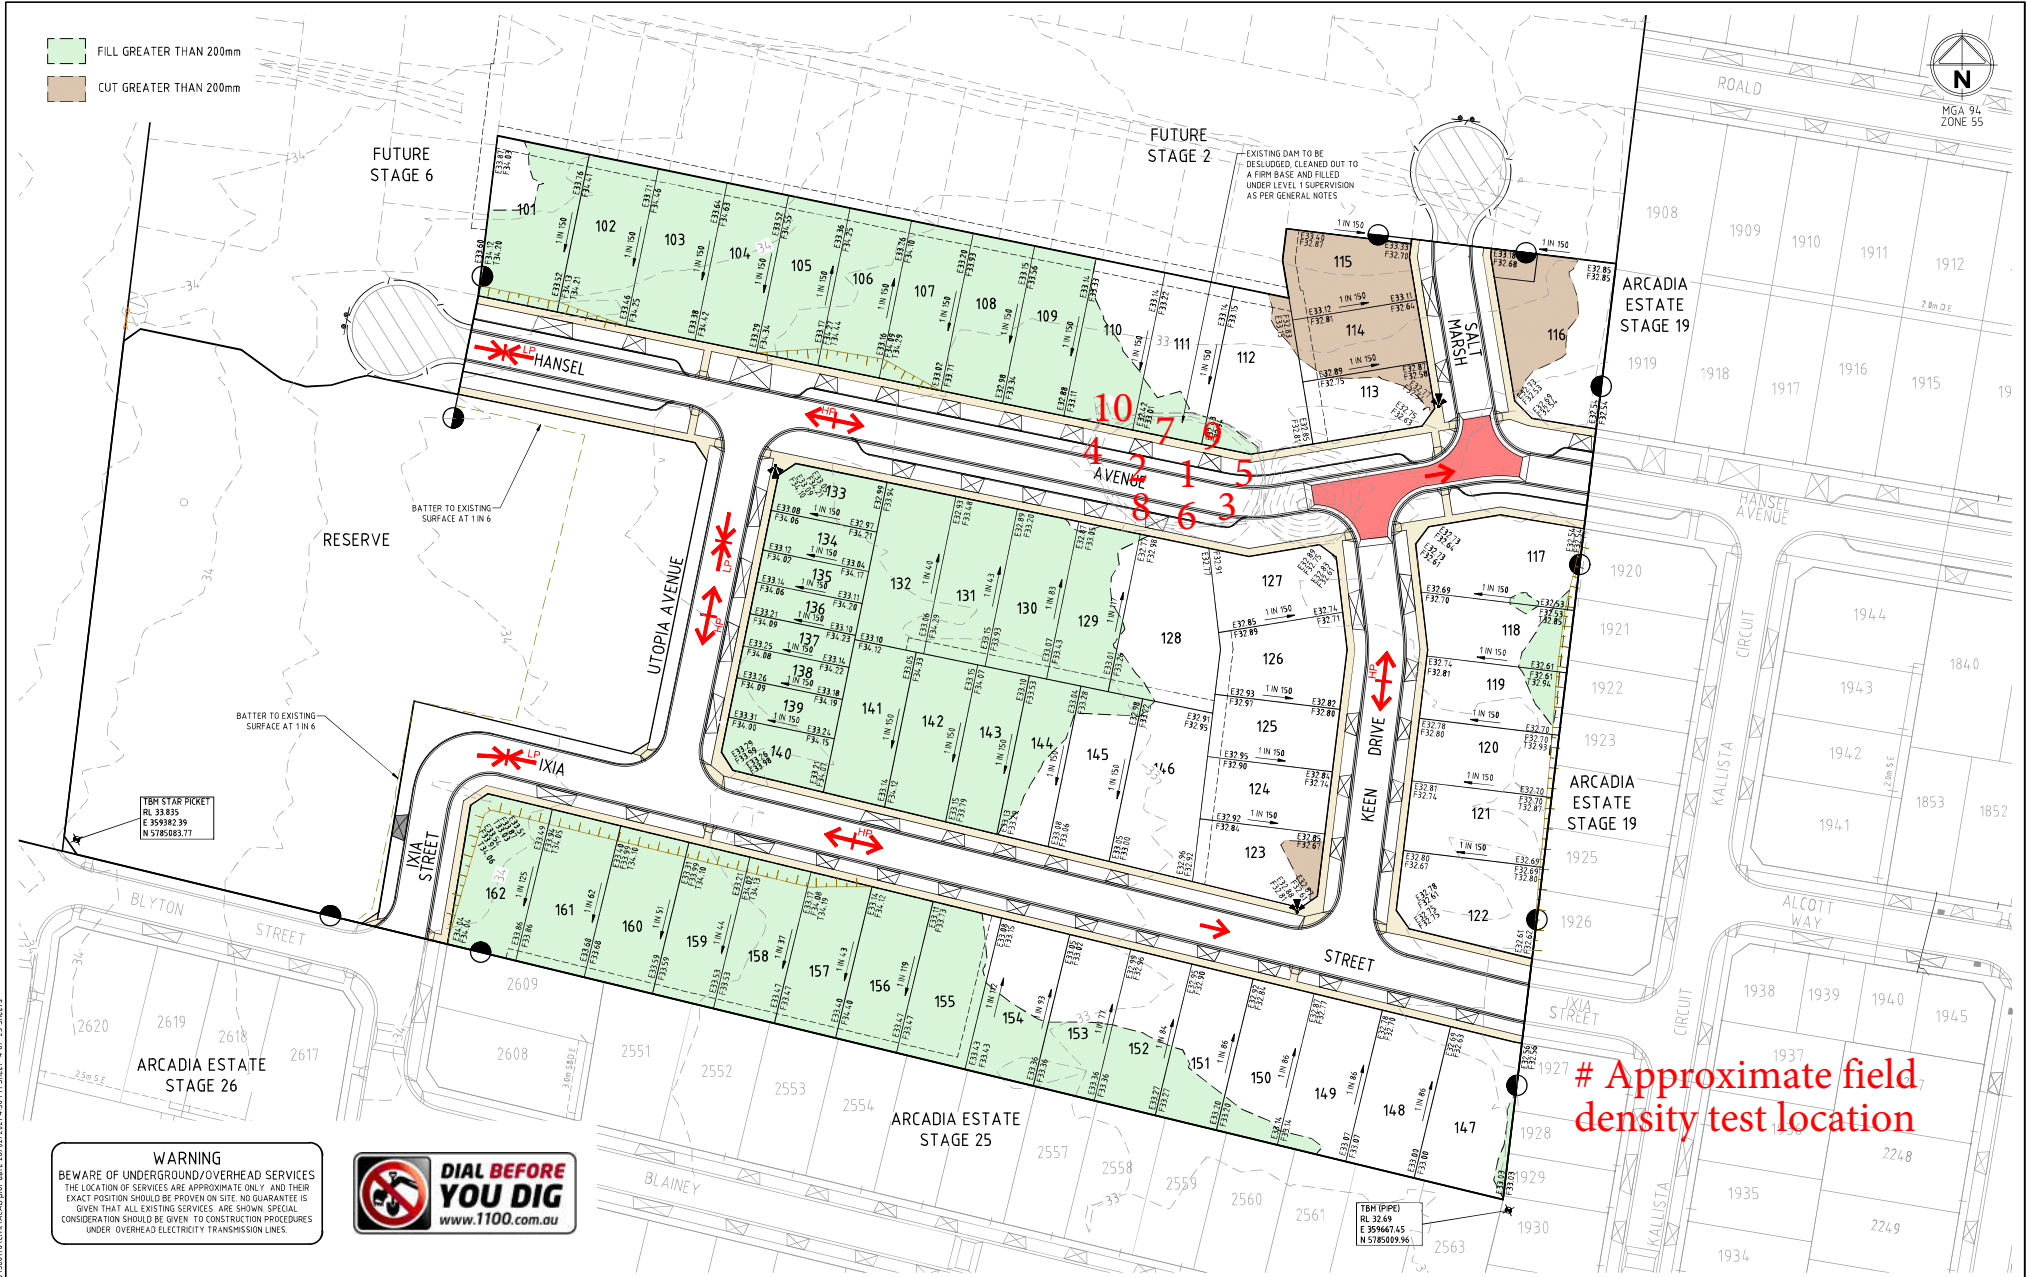
FIGURE 1

The site inspection and testing was performed by experienced geotechnicians from this office. Any areas that were deemed unsatisfactory were reworked and retested under their supervision. The testing was performed to the relevant Australian Standards and the accompanying test reports carry NATA endorsement. The attached compaction results, which were located randomly throughout the fill profile, are considered to be representative of the bulk fill materials that were placed across the reported allotments by Winslow Constructors during the aforementioned period. The approximate locations of the field density tests can be seen on the attached plan (Figure 1).

We are of the view that the bulk fill materials that have been placed across the reported allotments by Winslow Constructors during the aforementioned period can be considered as having been placed in a controlled manner to a minimum density ratio of 95% (standard compactive effort).
